Made easy – Hearing instrument adjustments

A guide for successful, efficient follow-up visits

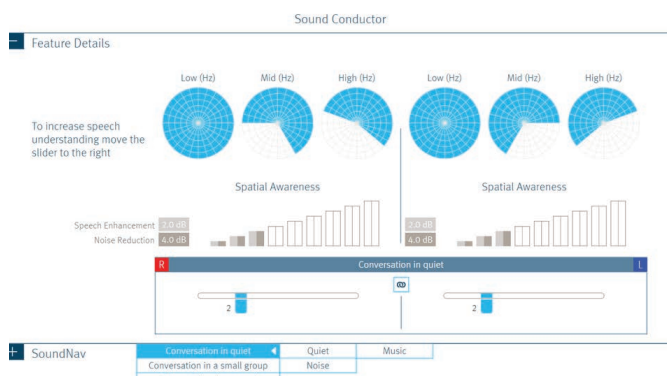
- Verify that the Sound Conductor settings are not significantly different between SoundNav destinations. Look at the Speech Enhancement and Noise Reduction values between each destination. [Fitting > Configure Features > Sound Conductor](#).

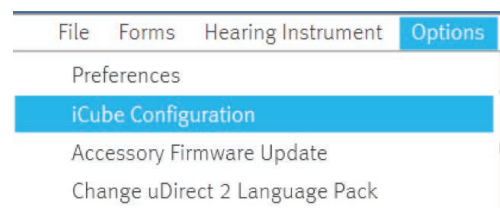
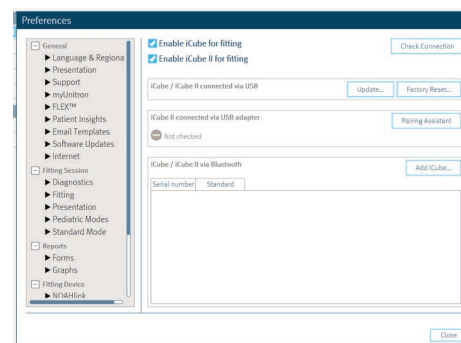
- Confirm programming interface.
- Troubleshoot the iCube II:
 1. Ensure iCube II is paired to the software. [Options > iCube Configuration](#).

2. Check age of the iCube II. The first two numbers in the serial number indicate the year of manufacture. If more than one year old, replacement is recommended.
3. Is iCube II adapter plugged into a USB hub? This may lead to inconsistent power (USB hubs sometimes spread the power across all USB connections). Plugging the USB directly into the computer may provide a stronger connection.
4. Uncheck iCube for fitting as software may default to iCube versus iCube II.
5. Clean contacts of iCube II adapter. Remove from USB port and clean with keyboard air blower.
6. Try a different neck loop.

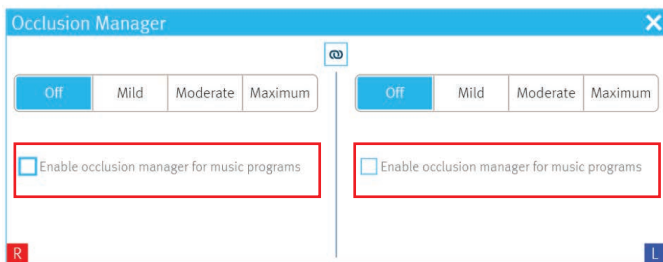
- Automatic controls – Adjust the sampling rate and speed of transitions between destinations. [Fitting > Configure Features > Automatic Controls](#).
- AntiShock™ 2 – A long term user may notice engagement. Reduce strength or disable. [Fitting > Configure Features > AntiShock 2](#).
- MPO – Values may be too low. [Fitting > Tuning > MPO/Gain/CR Controls](#).
- Occlusion manager – Default is off for music in order to keep music sounding natural. With low frequency losses and closed fittings, patients may hear fluctuations in volume when switching into music.
 - [Fitting > Tuning > Occlusion Manager](#). Check “enable occlusion manager for music programs.”

- Gain/Sound Conductor – Verify that the settings are not significantly different between destinations.
 - Check gain differences between SoundNav destinations. [Fitting > Tuning > MPO/Gain/CR Controls](#).
 - Check Sound Conductor settings between destinations. Look at the Speech Enhancement and Noise Reduction values between each destination. [Fitting > Configure Features > Sound Conductor](#).

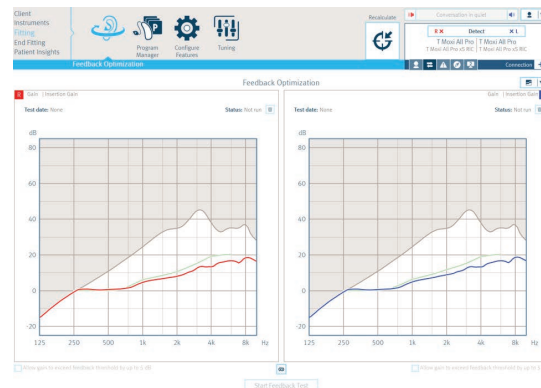
- If feedback persists, run feedback test. [Fitting > Feedback Optimization](#).

Note: After the test is run, it can be deleted. To add 5 dB of gain, check “Allow gain to exceed feedback threshold by up to 5 dB” under the graph.
